## Hazardous Materials Inspection

| <b>Facility Owner</b><br>Hope College | <b>Facility I.D.</b><br>Knickerbocker Theater<br>86 East 8th Street<br>Holland, MI 49423 |
| <b>Project No.</b><br><b>Date of Inspection</b><br><b>Name of Inspector</b><br><b>Inspector Accreditation No.</b> | G080483A52<br>September 16, 2008<br>Mr. Christopher D. Carew<br>A35073 |

Hope College  
Holland, Michigan  
Hazardous Materials Inspections - 2008

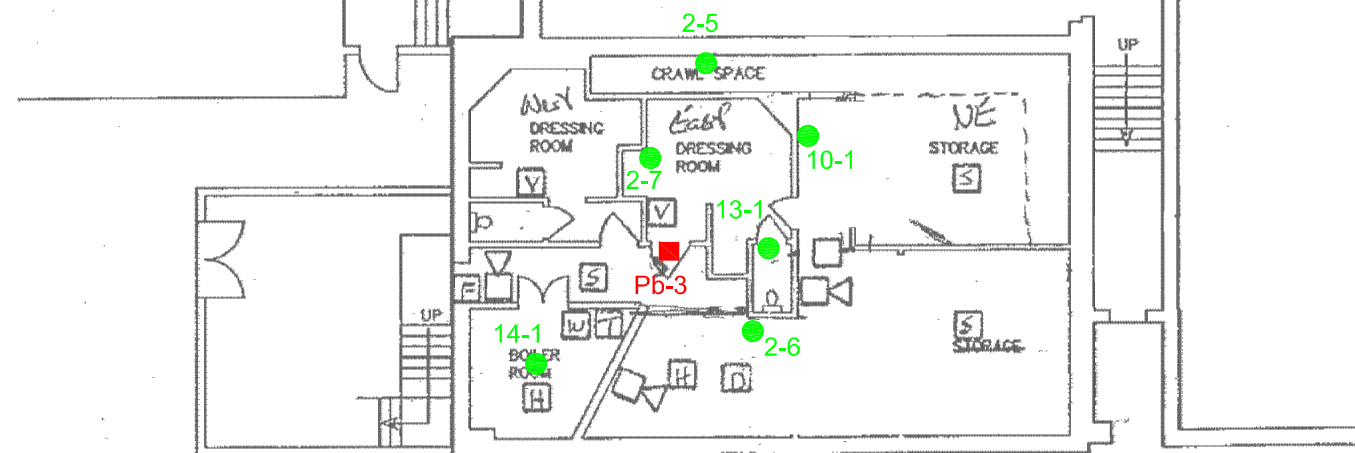
## BASEMENT FLOOR PLAN

| Sample Number | Sample Location | Asbestos % | Notes |
|---|---|---|---|
| KNB-11-1 | Basement, mechanical room, NE corner | 65% Chrysotile | Pipe fitting |
| KNB-14-1 | Basement boiler room, center of room | 30% Chrysotile | Insulation |

| Location I.D. (Room Number) | HA Number | |
|---|---|---|
| Basement Mechanical Room | 2 | |
| Basement West Dressing Room | | 9 |
| Basement Hall | 1 | 18 |
| Basement Boiler Room | | 9 |

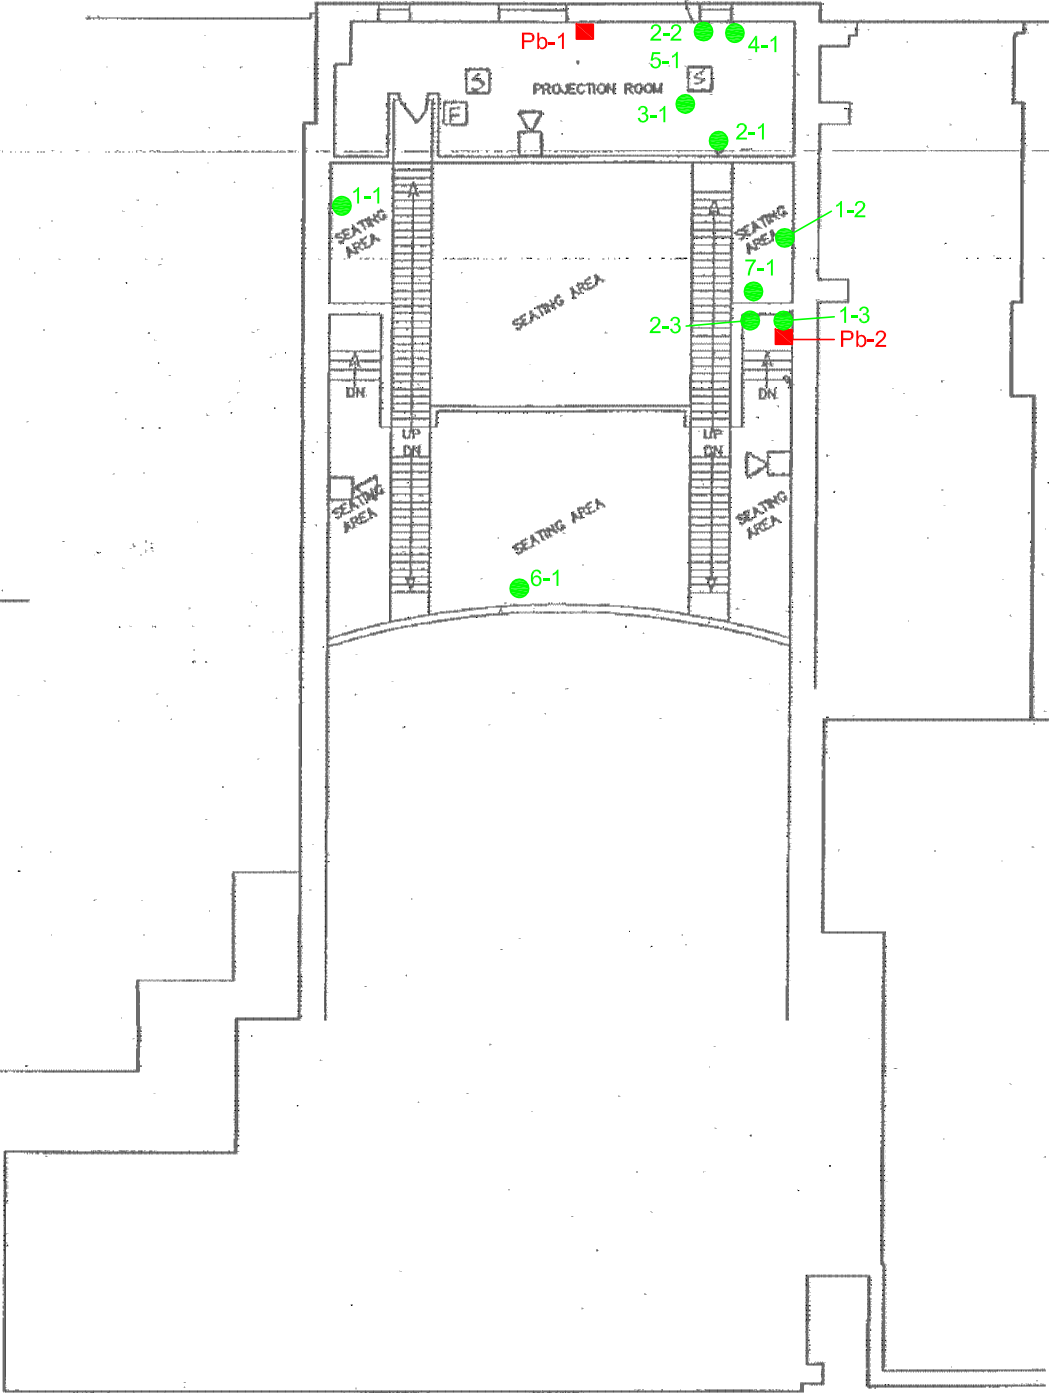
BALCONY FLOOR PLAN

| Sample ID | Sample Site | Description | Lead Concentration<br>(% by wt) |
|---|---|---|---|
| KNB-PB-2 | Balcony stairwell, east wall | Beige, interior | 2.6 |
