# **ASBESTOS INSPECTION**

## **VANDER WERF HALL**

**PREPARED FOR:  
HOPE COLLEGE  
HOLLAND, MICHIGAN**

**SEPTEMBER 13, 2007  
PROJECT NO. G07453E**

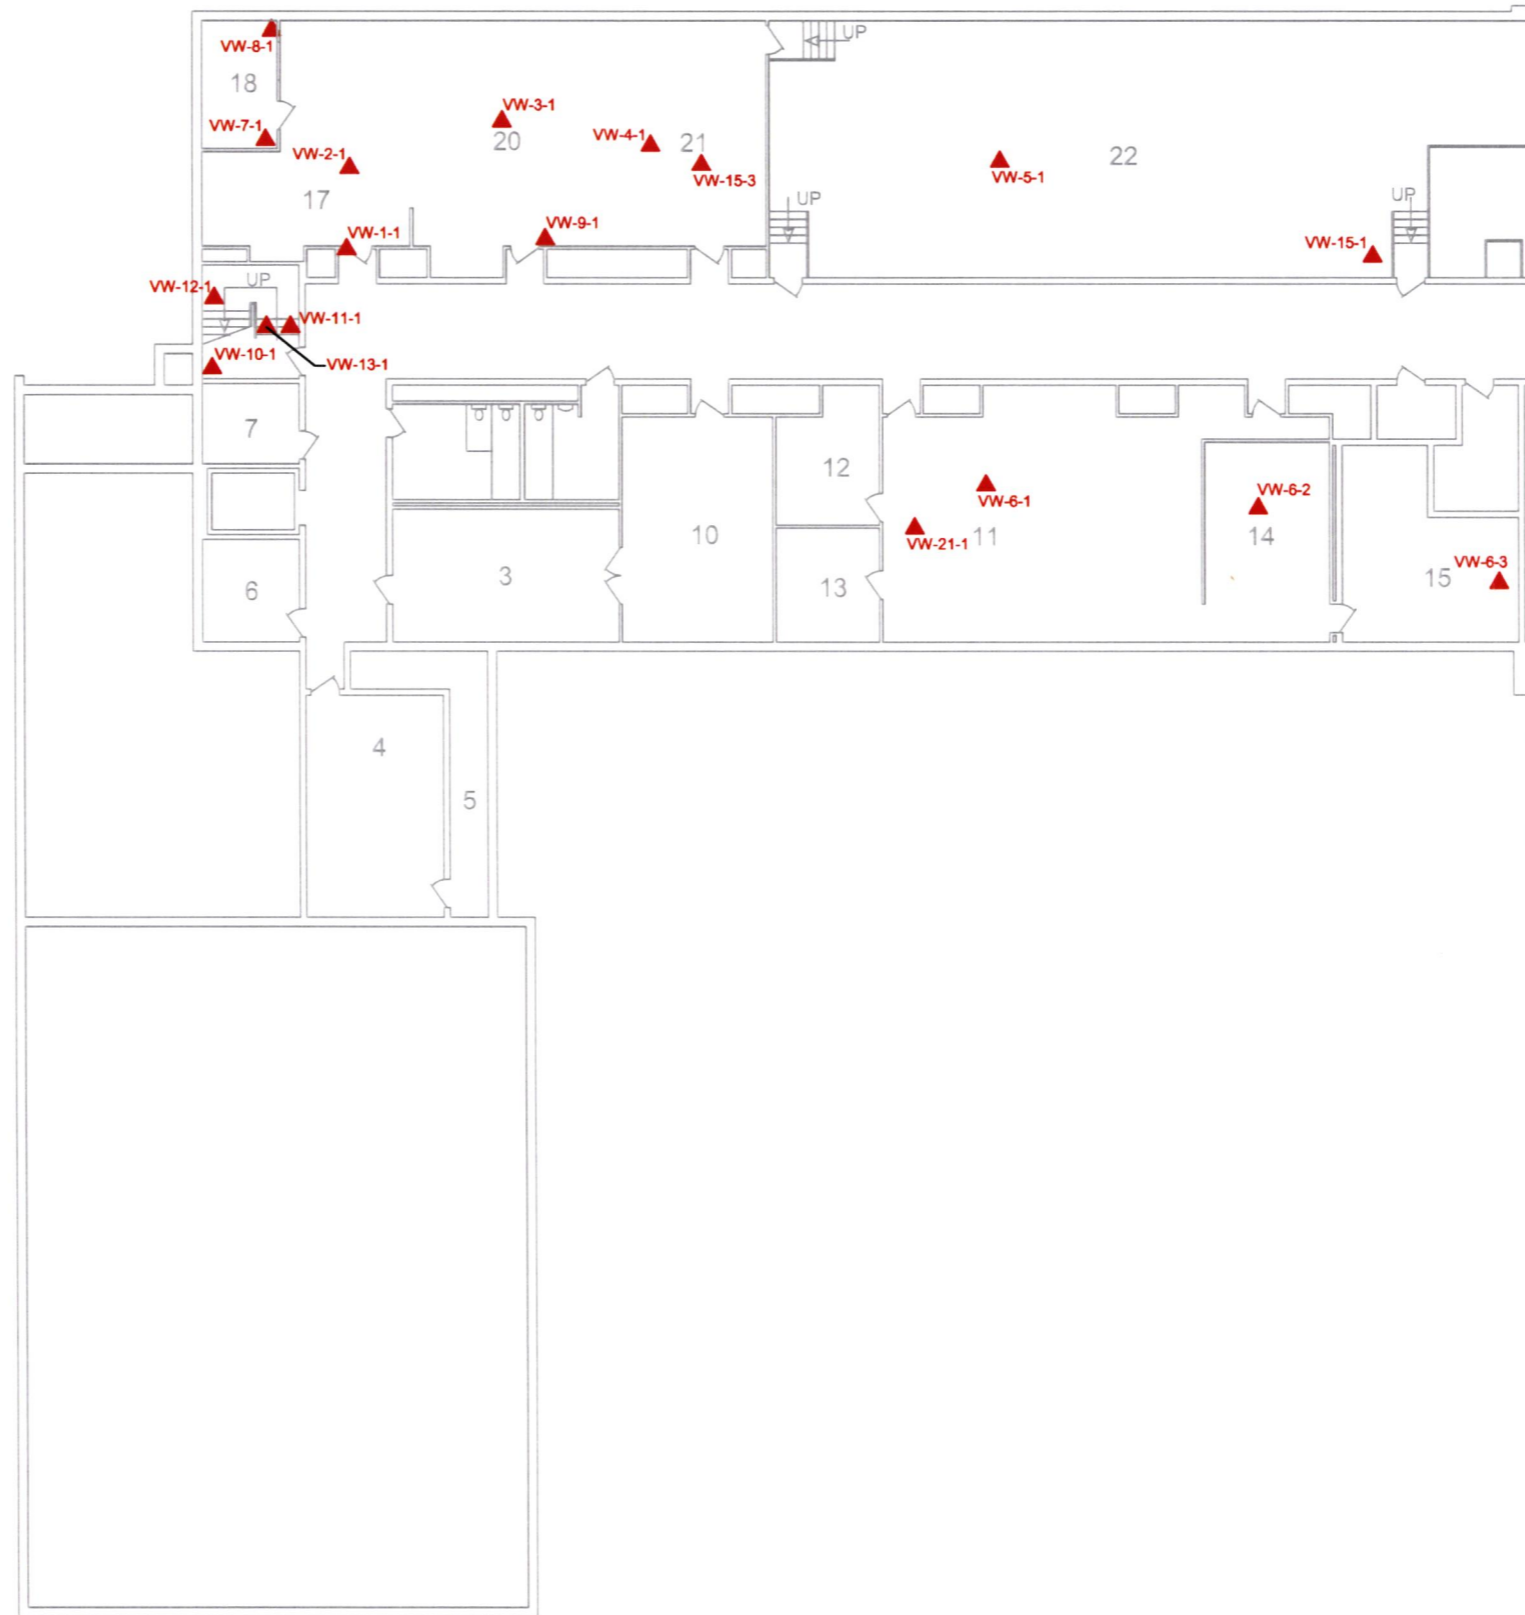
**SAMPLE LOCATION MAP**  
GROUND FLOOR

VW-5-1 ▲ - SAMPLE LOCATION  
(APPROXIMATE)

Figure 1	Sample Location Map – Ground Floor
Figure 2	Sample Location Map – First Floor
Figure 3	Sample Location Map – Second Floor

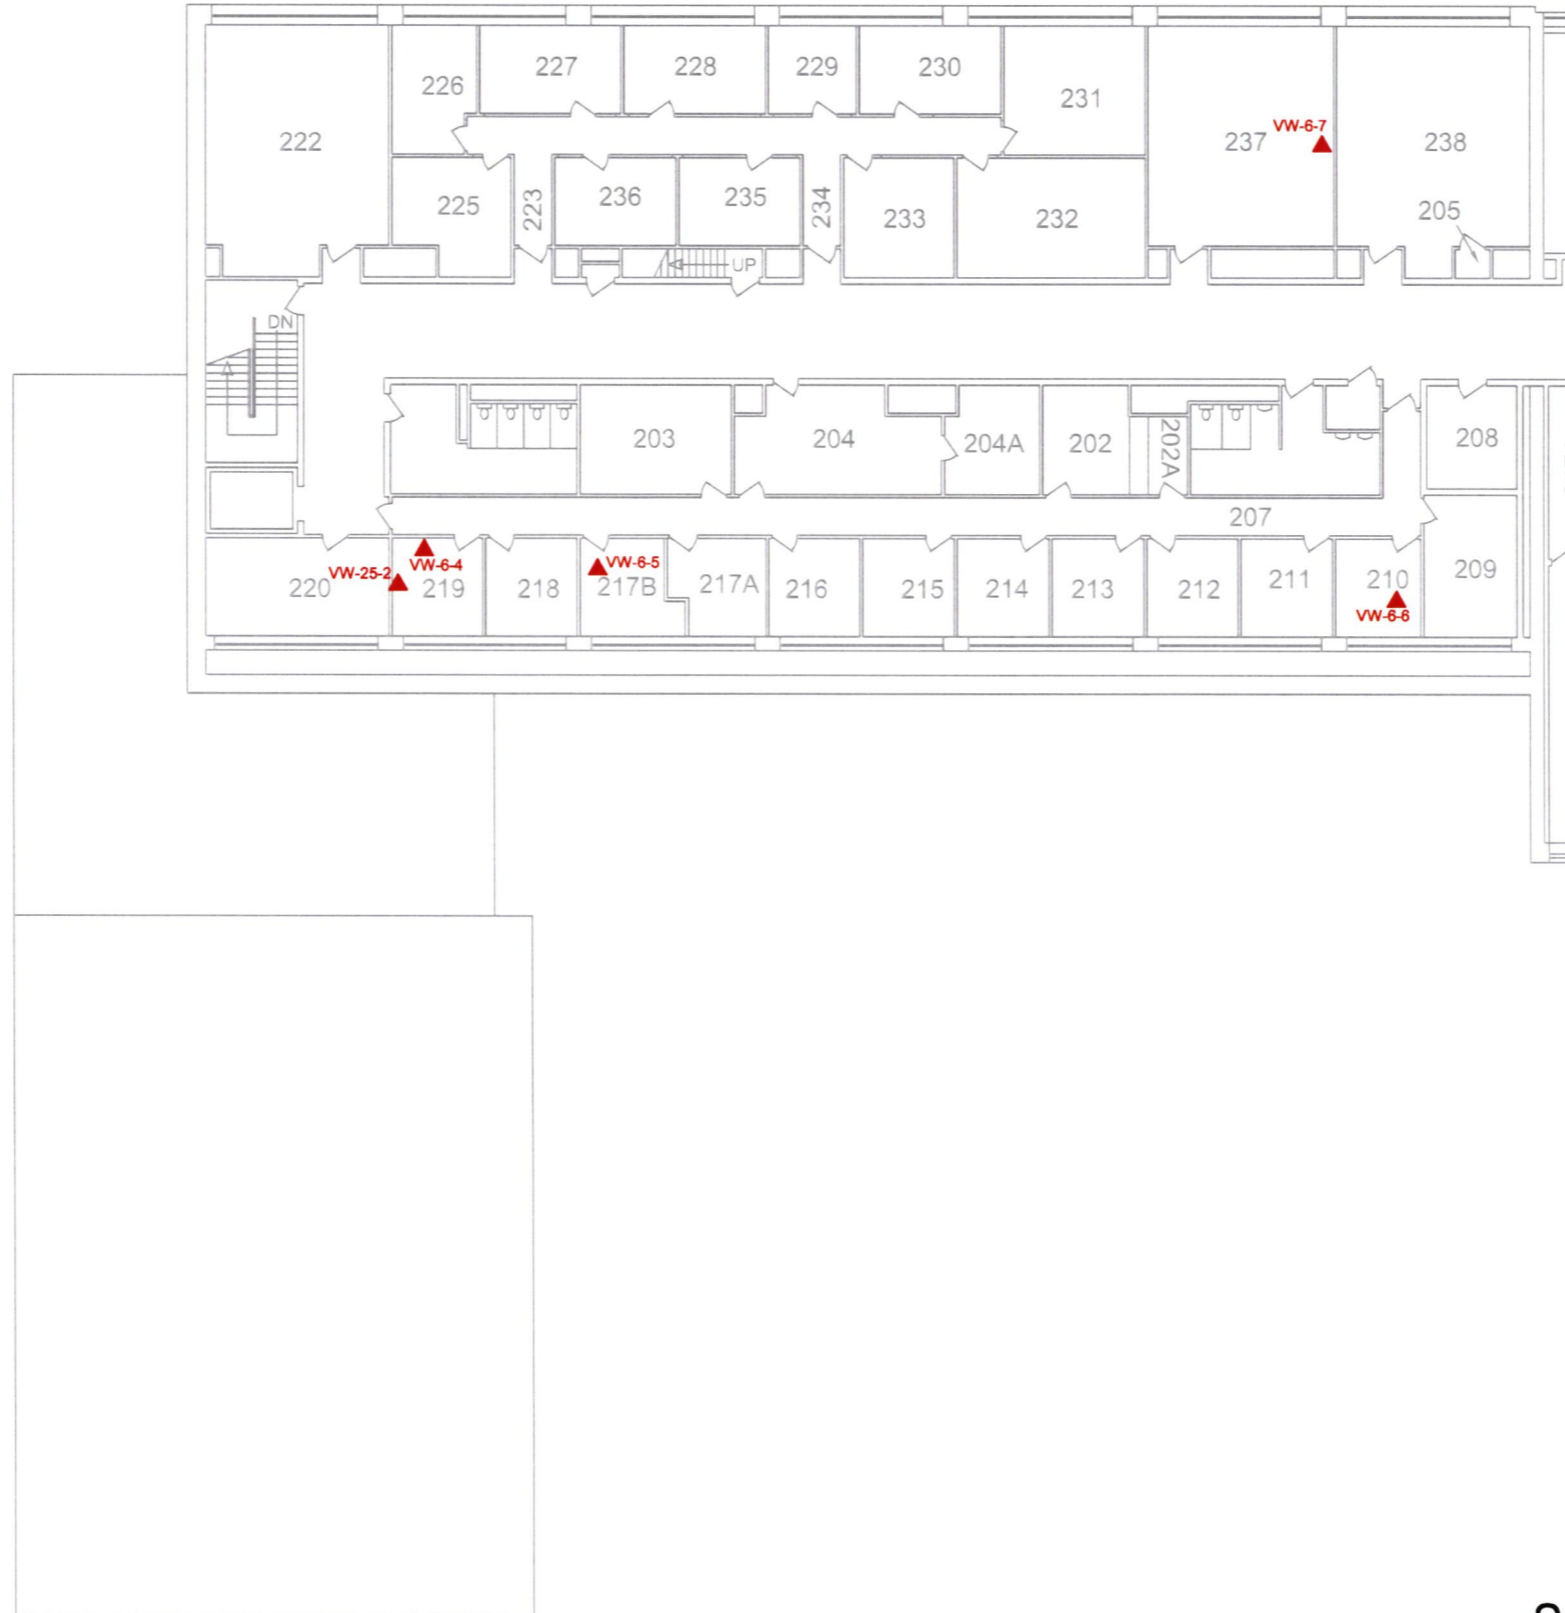
**SAMPLE LOCATION MAP**  
SECOND FLOOR

VW-25-2 ▲ - SAMPLE LOCATION  
(APPROXIMATE)
